Vibration Assessment for Steel Structure with Viscous Damper Application in Oil & Gas Industry

At an offshore facility suspected due to vibration issue, several welding failures were observed at the small-bore connection (SBC) of 30” nitrogen piping system from centrifugal compressor causing integrity, operational, and safety concern.

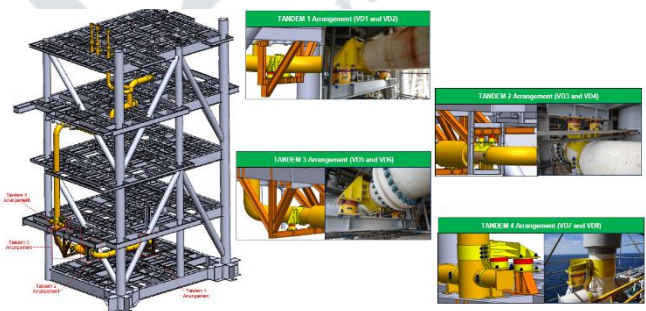
There are several methods to resolve the vibration issue with main consideration on live operating offshore construction complexity. Viscous dampers were proposed as it has more advantages as compared to other typical vibration support systems such as hydraulic snubbers, rigid struts, vibration clamps, etc. One of the dominant advantages of viscous damper is that it will only transfer a minimal dynamic load from vibrating piping to the structure. In addition, the installation can be carried out without the needs to shut down the facility.

Fig. 1 Overview of Viscous Dampers Installation Location (Source: PETRONAS [5]).

Based on post installation result measured and continuous monitoring on VM result (after 3 months installation), the vibration levels on piping and structure were observed to be under acceptable limit thus enabling safe operation of the offshore facility as per design. It can be concluded that with installation of viscous dampers and its supporting structures, vibration issue can be resolved with minimum modification

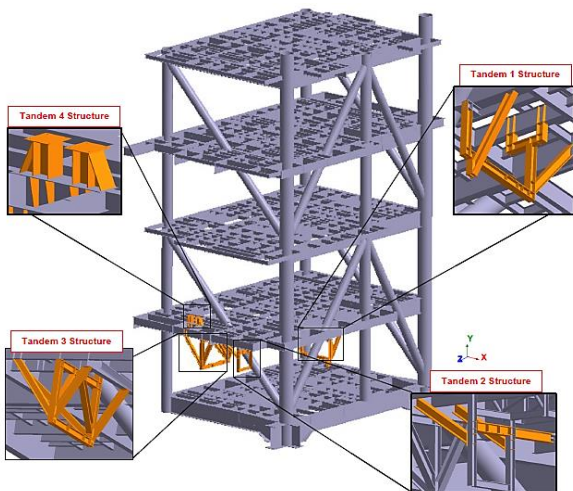
Fig. 3 FEA Model of Structure 2 (Post-Modification) (Source: PETRONAS [5]).

Two FEA models were created for structural analysis which are existing structure pre-modification (Structure 1) and structure post-modification with viscous dampers and its additional supporting structure installation (Structure 2, as shown in Fig. 3 above). Each analysis case was analyzed for both static and dynamic condition, as presented in Table I.

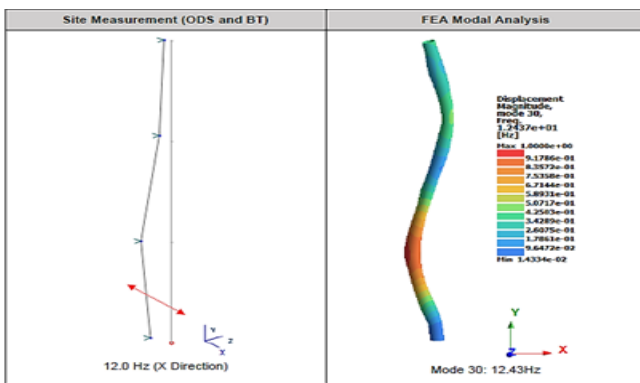
Operational Deflection Shape (ODS) data was extracted based on BT result to evaluate the dynamic characteristic of the structure against simulation. The results for measured BT and against calculated natural frequency from modal analysis simulation varies less than 10%, thus the model is within the reasonable accuracy. Table III shows the BT result measured

Fig. 4 Result Validation (Source: PETRONAS [5]).

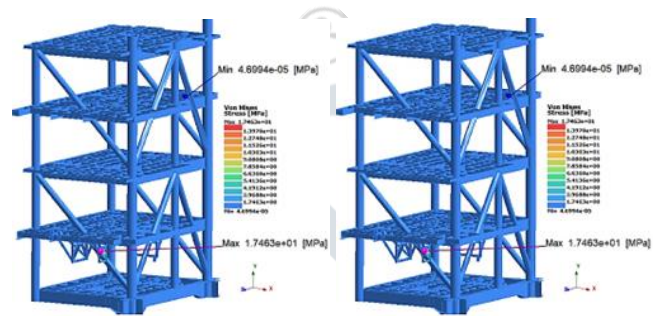
Based on the static and dynamic analyses performed on the structure, the results indicated that steel structure post-modification are safe since the maximum equivalent stress is below the allowable stress. Dynamic displacement at the support structure supporting viscous dampers is within allowable displacement at 3 Hz excitation frequency to meet DIN 4150-3 [3] criteria of 0.53 mm (0 to Peak). Summary of the analysis result are tabulated in Table IV below.

Failure criterion was based on Von Misses Stress criteria whereby the equivalent stress value of the steel structure shall not exceed the ASTM A36 material allowable stress of 150 MPa, calculated using safety factor of 1.67 for Allowable Stress Design (ASD) method as per AISC 360-16 [1]. Fig. 5 shows the FEA result plots for post-modification dynamic analysis.

Fig. 5 Overall Static (Left) and Dynamic (Right) Stress Result for Post-Modification (Source: PETRONAS [5]).
